CAPTAIN'S REPORT

TUG MACKENZIE ROSE INCIDENT

**UNITED STATES DISTRICT COURT
EASTERN DISTRICT OF VIRGINIA: NORFOLK DIVISION
Case No. 2:24-cv-00490**

July 2, 2025

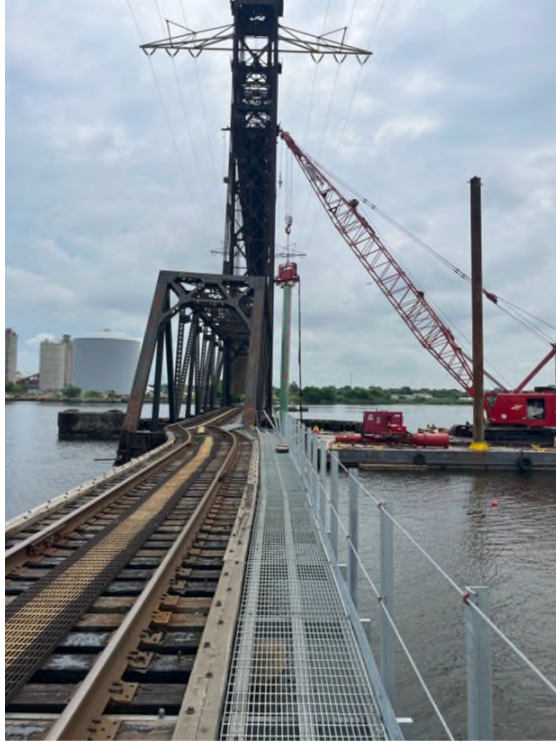
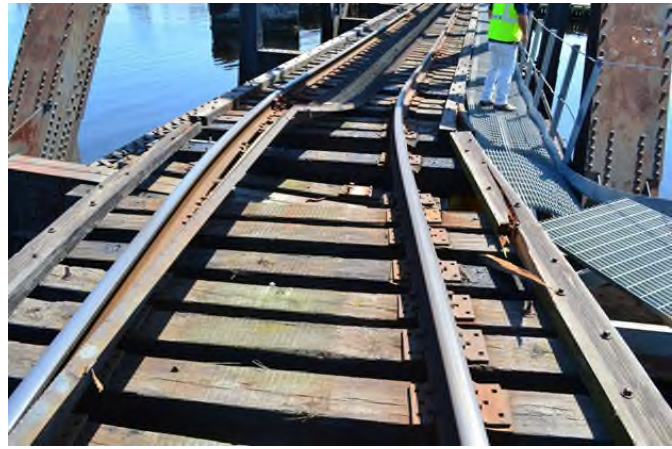
NPBL Bridge damage on June 15, 2024

1. The unit made direct contact with the bridge, causing visible structural movement (as evidenced by surveillance video), which is contrary to crew statements of “no damage” or “minor impact.”
